Maryland Historical Trust

Historic Properties Form

Inventory No. M: 20/32

historic Irvington Farm

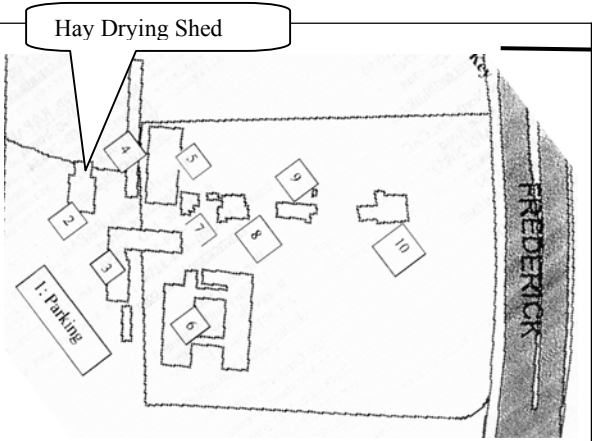
| <p>General: The Hay Drying Shed sits on a flat area, with overgrown weeds and shrubs. The metal roof is in poor condition, and the sagging plate indicates some structural deficiencies. The shed is open on three sides, but has a drying loft or room at the north end, supported by metal pipes to carry the weight of the machinery inside.</p> <p>Character-defining elements: Massing, materials, functional design elements including ceiling hatches and wheel channels, machinery.</p> | |

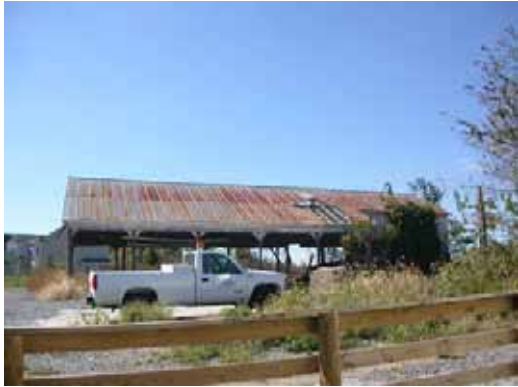
| <p>Surrounding Environment: The barn sits on a gradually rolling hill, which falls towards the north façade. Landscaping around the drying barn consists of brush and scrub trees that encroach on the building. Vines are climbing on the north façade.</p> | |

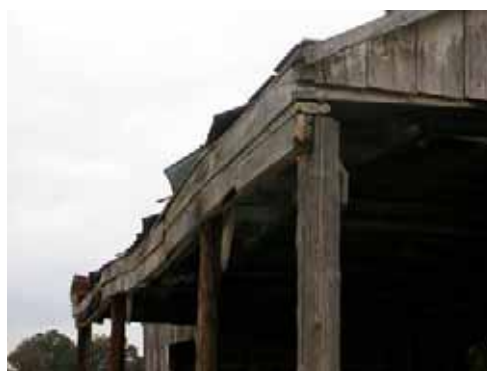
Condition of plates

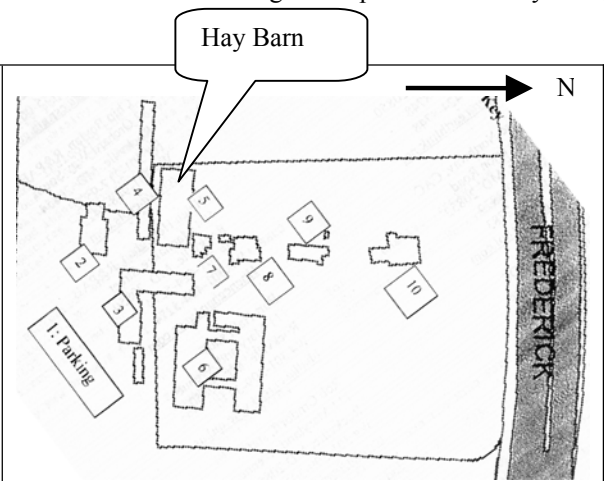
East (front) Façade: The main façade has two entrances: one for the main portion of the barn, and the other to the farm office, with a small kitchen area. For the barn entrance, a large sliding wood door accommodated machinery and animals. Within the frame of this sliding door, there is a single-leaf door. The office entrance has a single-leaf, half-glaze (2/2) wood paneled door. There is a rectangular, slatted vent at the gable peak. The German siding has been patched in places.

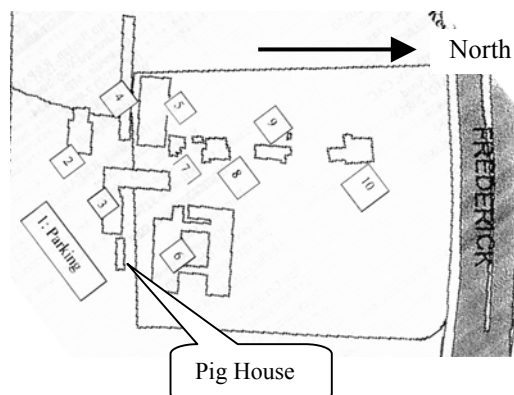
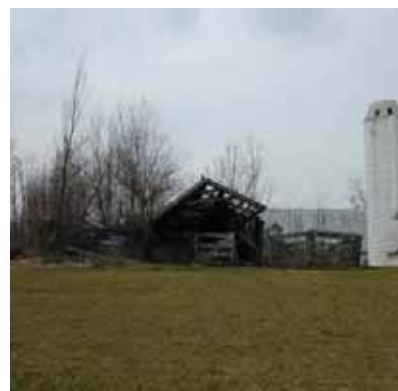
Pig House: View of east elevation, of the dilapidated structure. This was a narrow gable-roofed structure placed just south of the Calf Barn.
